Job title: Pontfaen Road, Lampeter

Report type: Geo-Environmental Appraisal

Prepared for: Aldi Stores Limited

REPORT REFERENCE GRO-20171-1550

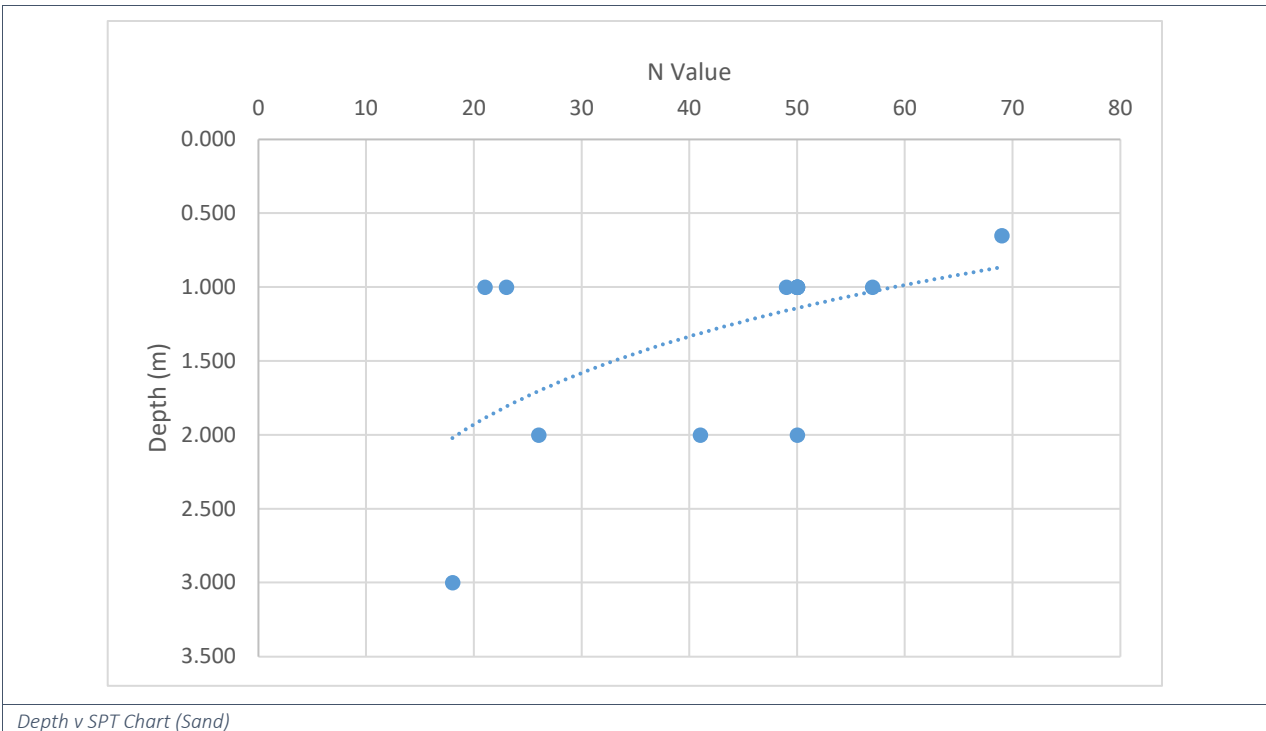
Depth v SPT Chart (Sand)

The geotechnical test results have been evaluated to derive geotechnical parameters for the soils underlying the site. A depth to SPT 'N' value graph is presented below to provide a generalised ground model for the site.

Characterization of the geotechnical parameters above has been undertaken to select a characteristic value, which is a cautious estimate of the value affecting the occurrence of the limit state.

Preliminary foundation design has been undertaken by calculation, a safe allowable bearing capacity of 175kN/m² is provided for ultimate limit state design for a 600mm wide strip or 1.2m square pad foundation constructed within the dense to very dense Sand/Gravel at a minimum depth of 0.6m bgl.
