**GROUNDTECH**  
CONSULTING

**Job title:** Aldi Porthcawl

**Report type:** Geo-Environmental Appraisal

**Prepared for:** Aldi Stores Limited

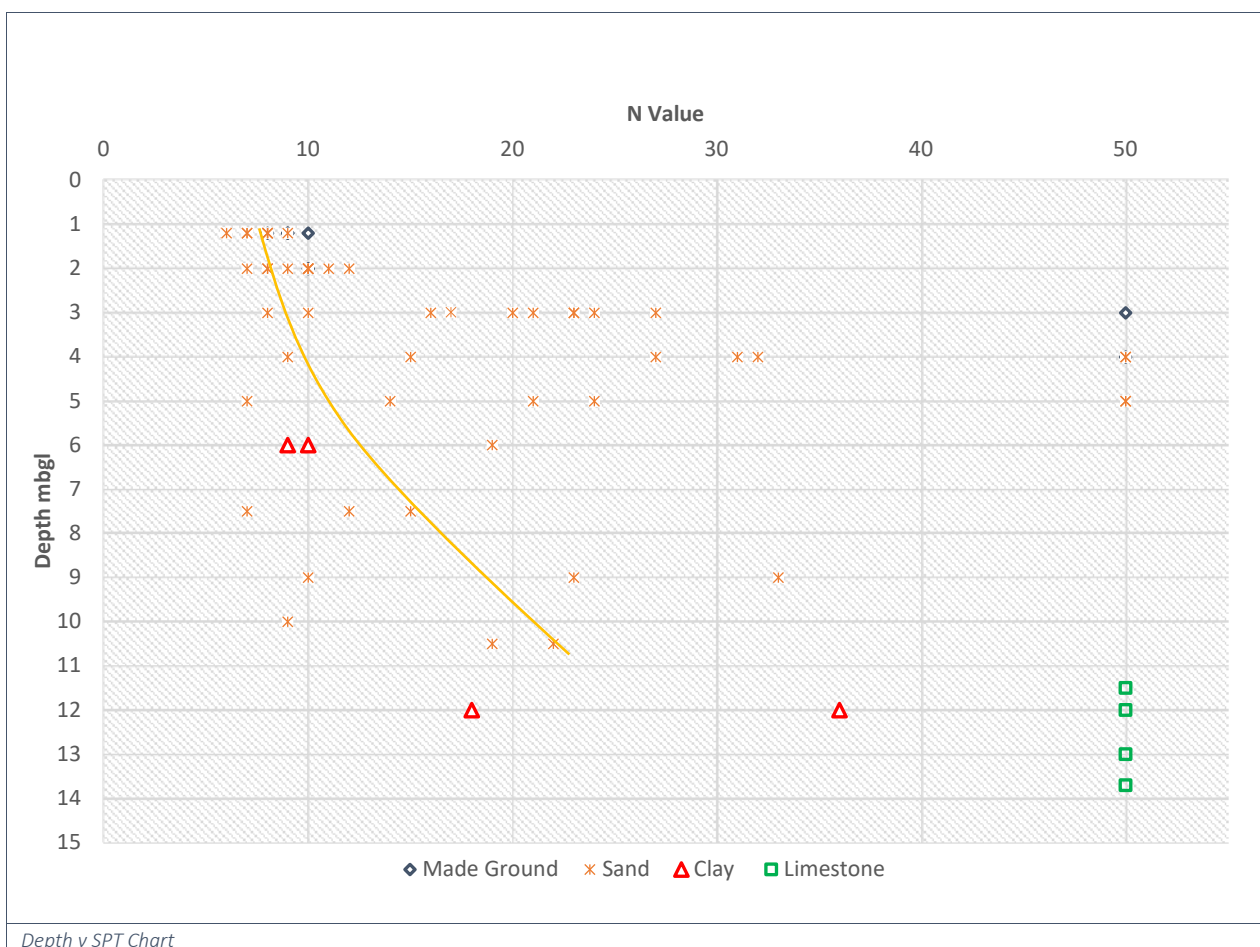
The geotechnical test results have been evaluated to derive geotechnical parameters for the soils underlying the site. A 'depth to SPT N value' graph is presented below to provide a generalised ground model for the site.

Characterisation of the geotechnical parameters above has been undertaken to select a characteristic value, which is a cautious estimate of the value affecting the occurrence of the limit state.

The characteristic values of the underlying strata have been selected based on correlation with SPT values and where possible, published values. The characteristic values for Ultimate Limit State (ULS) selected are presented in the table below:
